TEST REPORT RAPPORTO DI PROVA

MES1357576B00TR

- 1.1.1 Product/material subjected to test:** Art. 5669/S
Prodotto/materiale sottoposto a prova:
- 1.1.2 Description:** Sliding system with soft closing and soft opening.
Descrizione:
- 1.1.3 Level (Series product, prototype, etc.):** Series
Livello (Prodotto di serie, prototipo, ecc.):
- 1.1.4 Part number:** Art. 5669/S
Codice prodotto:
- 1.1.5 Serial number:** None
N° Matricola:
- 1.1.6 Sample identification code:** Test from the client.
Codice identificativo del campione:

7.1 TEST N.1 – FATIGUE TEST

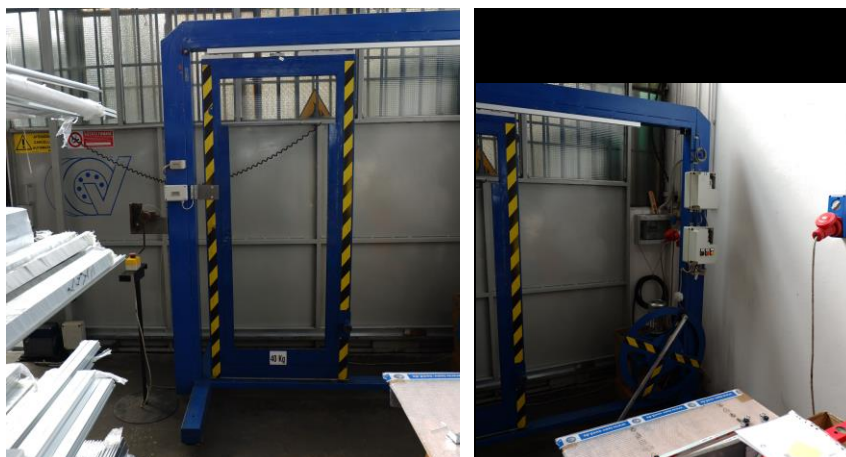
1.3 TEST CONFIGURATION

Test configuration without load test.

Mechanical system for open and closed the door, with a 1-meter in-out run and 1 meter in return.
